# Post Incident Analysis Report

**MFB Burnley Complex  
450 Burnley Street  
Richmond VIC 3121**

Lacrosse Docklands  
673-675 La Trobe Street, Docklands  
25 November 2014

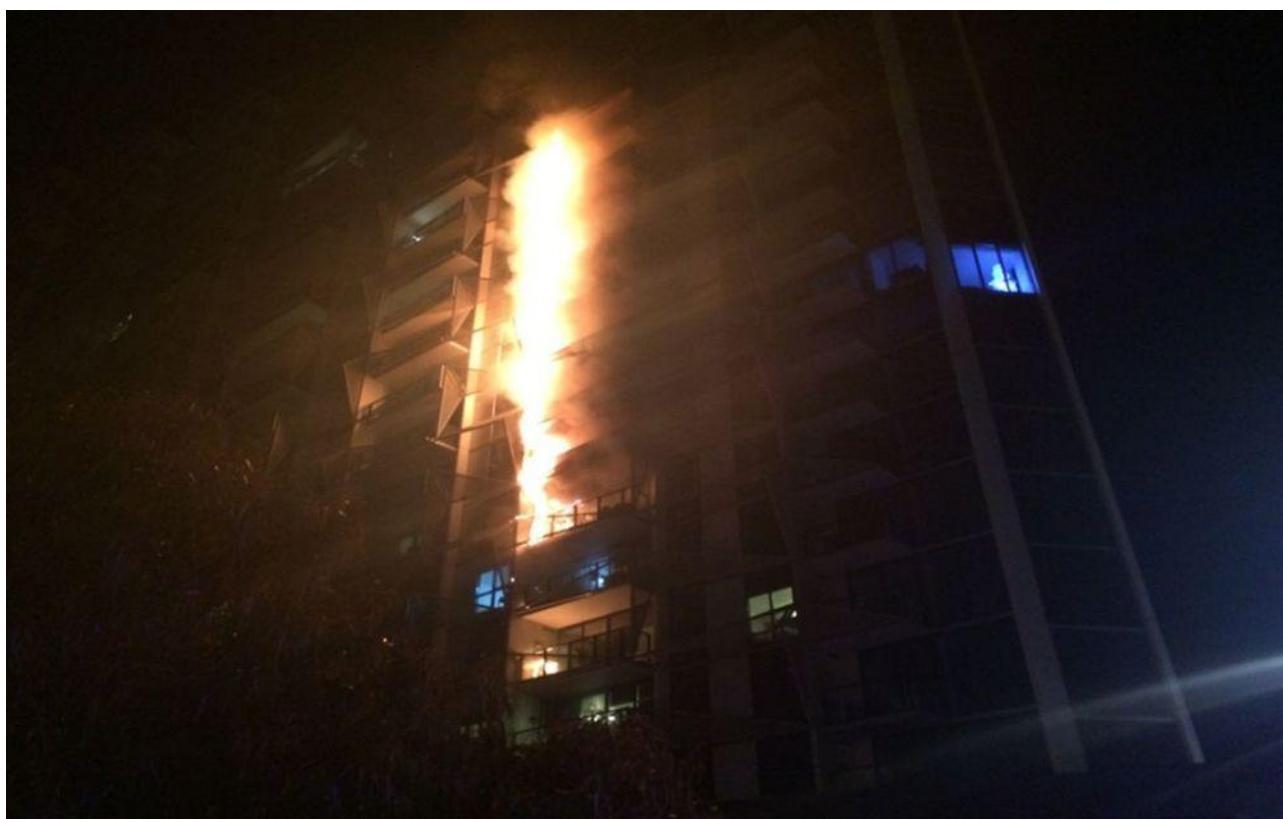
The occupants from Level 6, Apartment 605 reported later to fire-fighters, seeing fire embers and flaming debris falling from levels above their apartment and igniting materials on their balcony. They then evacuated the building. See photograph below.

**Figure 2 – Shows fire on level 6 and fire on level 8 (point of origin) extending up to level 14 (02:29)**

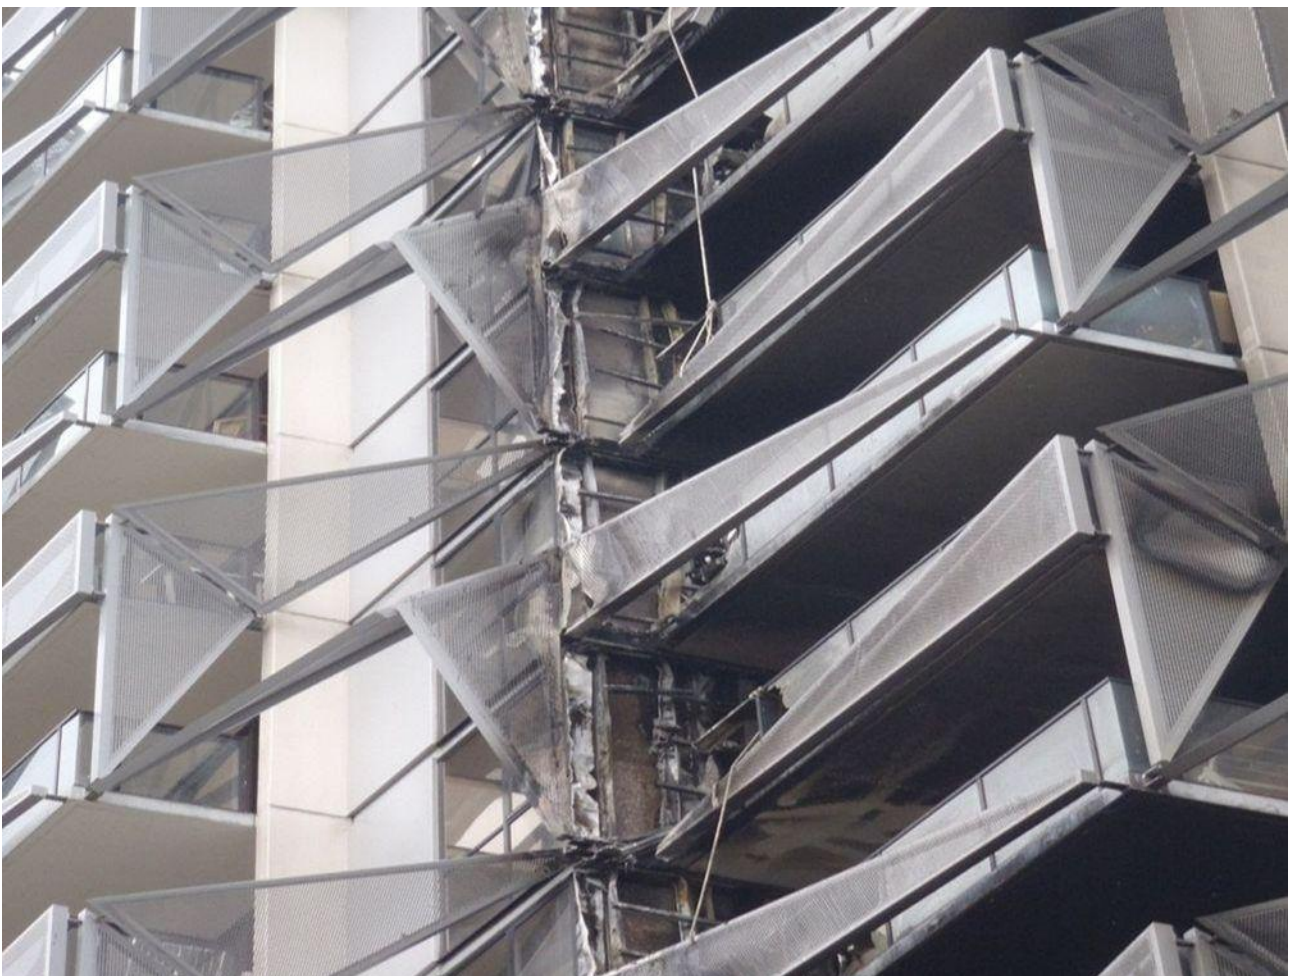
Fire damage was essentially restricted to the façade and external balcony area adjacent to Apartment 605 and Apartments 805 to 2105. Please refer to the [Fire Cause and Origin section](#) of this report for further information on fire damage.

**Figure 3 - Fire damage to the external wall cladding and ornamental structures**

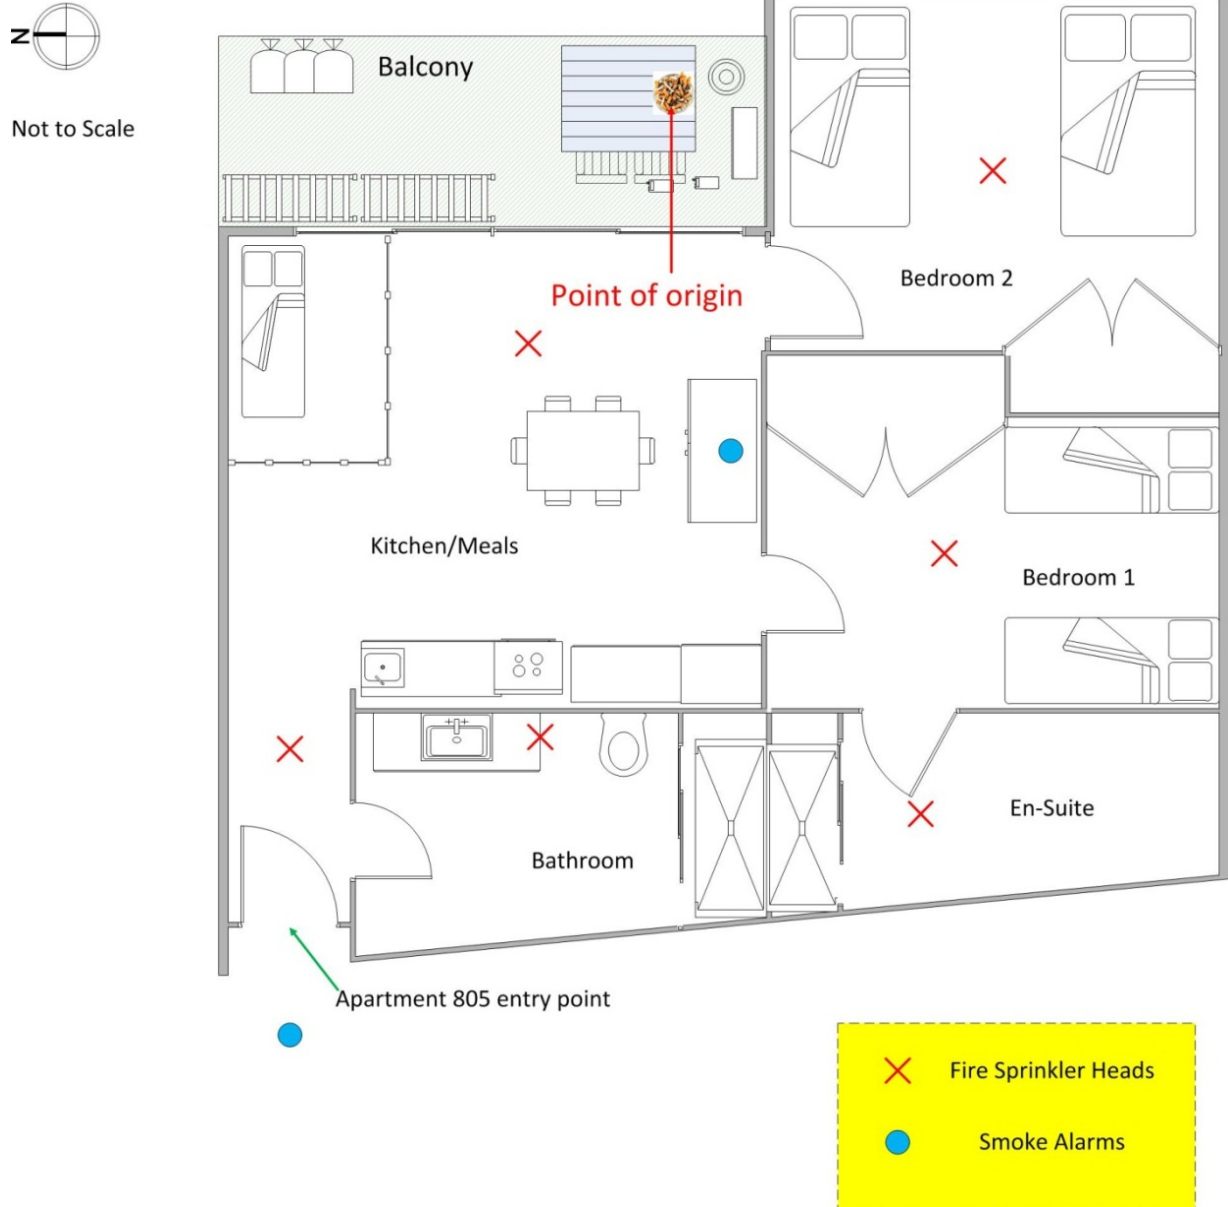
Figure 4 – Point of Origin

Positioned on the balcony approximately 200mm to the north of the A/C unit and the wire basket, were the remains of an outdoor setting with two steel framed plastic chairs and a steel framed timber slatted table. The two chairs were positioned in a north south line along the balcony and had sustained severe damage by the fire. The chair located further from the A/C unit had fire affected remains of the plastic chair still attached to it. The chair positioned closer to the A/C unit had no visible plastic remains evident. Across the back of the steel frames of the chairs was a burn pattern that was lower to floor level towards the A/C unit.

Further examination found fire debris on the floor of the balcony area, close to the first vertical upright of the balustrade; approximately 1 metre from the southern wall of the balcony revealed a number of fire affected cigarette butts. Some of these butts had been severely affected by fire, with minimal amounts of the filter section remaining and being burnt through, indicating prolonged or severe exposure to the fire.

Also located in the fire debris in this area, were the remains of matches that had been burnt. The match and some of the cigarette butts were located on top of the remains of a white plastic material. These white remains appeared to be from a plastic container and were located on the tiles of the balcony floor, with other fire affected debris around them and the fire affected glass from the balustrading on-top of them. This glass had sustained sooting to it and had been affected by the heat from the fire.

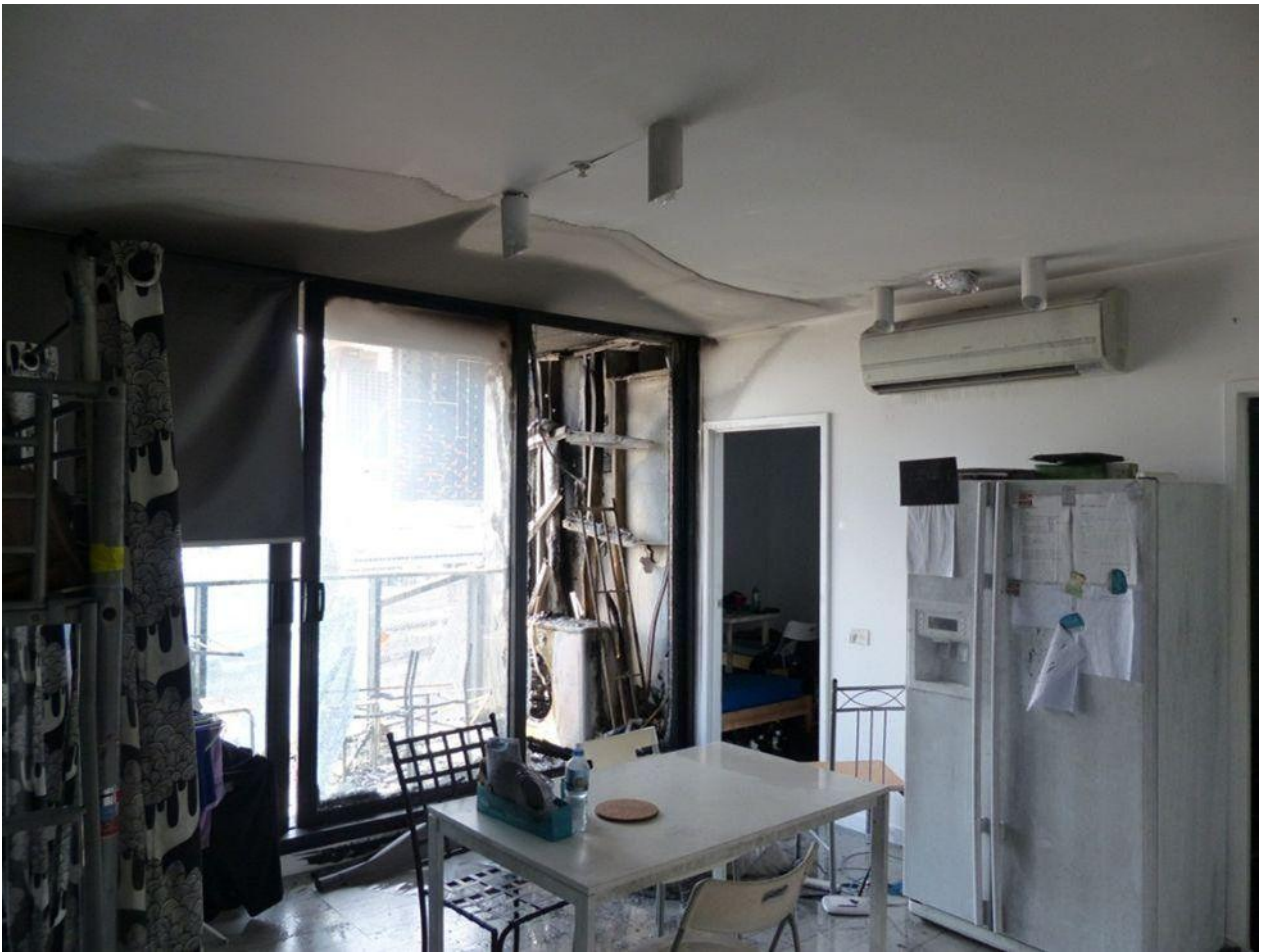
Full height glass double glazed sliding doors gave access to the balcony area from the kitchen. These had sustained heat and fire damage with the glass from the fixed panel located at the southern end of the balcony, breaking and collapsing to the floor areas of the kitchen and balcony. At the time of the investigation the double sliding doors were in the open position, with a visible gap of approximately 50mm between the two sliding doors. Access for investigation purposes was gained through the broken fixed panel at the southern end of the balcony area.

**Figure 5 – Picture 4: Inside kitchen looking towards double glass sliding doors leading to balcony area & bedroom 2.**

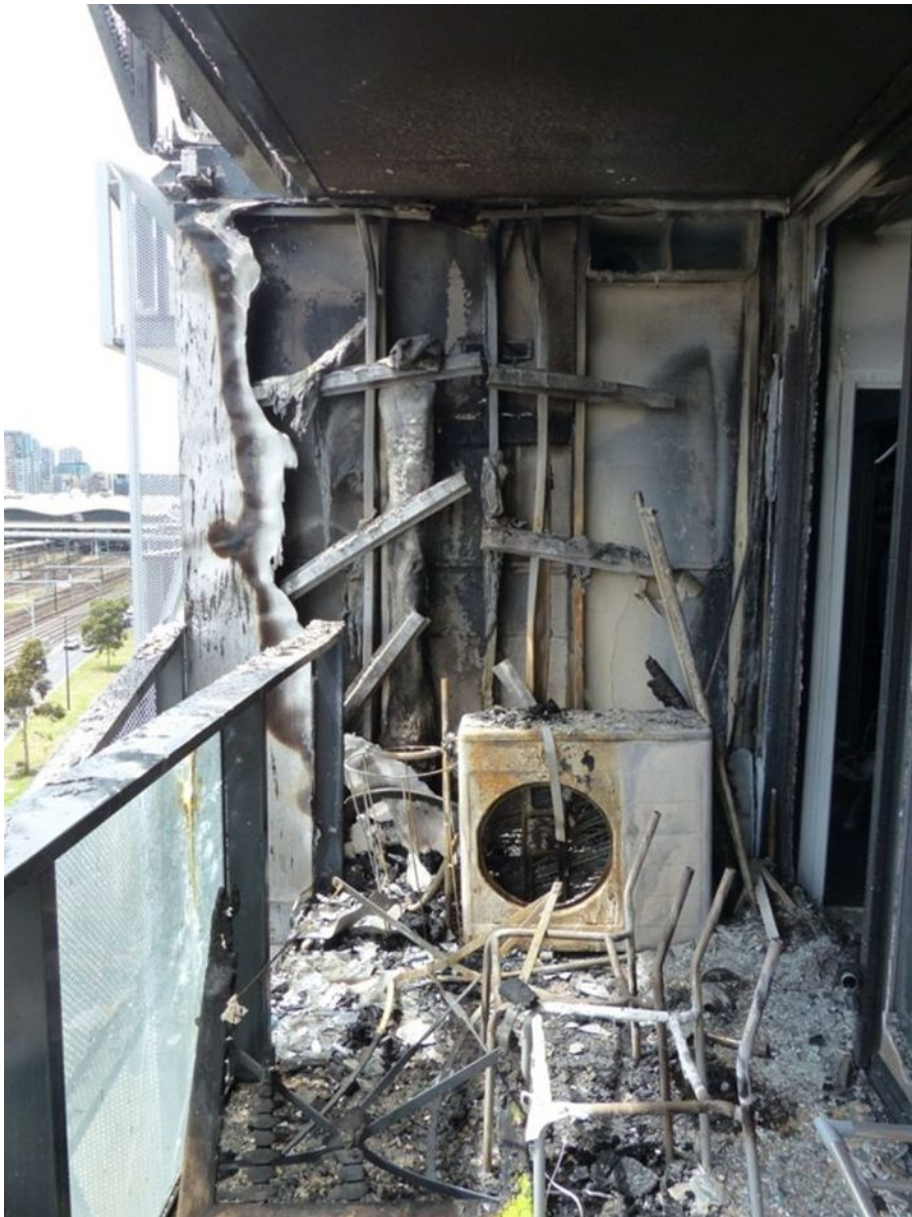
Fire damage to the southern wall was severe with consumption of almost the entire aluminium wall cladding (Alucobest). A 'V' pattern to this wall emanated from floor level of the balcony across the entire width. A small section of vertical wall, approximately 400mm protruded past the balcony balustrade allowing the fire to progress upwards to the balcony above. The section of aluminium cladding that remained outside the balcony created a 'V' pattern emanating from the balcony of this apartment.

Examination of the wall components revealed severe distortion to the steel frame and consumption of combustible components located in the wall. Severe burning to the back of the plaster had occurred with cracks and breaking down of the plaster's stability occurring. Intense burning had occurred in the area of the PVC downpipe, which had been consumed between the tiled floor and the concrete ceiling of the balcony. Prior to the fire, an exterior light had been mounted to the wall above the A/C unit. Although no remains of this light were located in the fire debris, burn patterns around the approximate mounting position on the wall do not suggest this light to be the point of origin for the fire.

The extremely vertical nature of the burn patterns to the exterior face of the wall suggest that the Alucobest aluminium cladding, along with the foam lagging and the PVC pipe of the building wall, contributed to the fire load and the rapid spread of the fire up the vertical face of the building to the floors and balcony areas located above.

**Figure 6 - Picture 5: South Wall Balcony of Apartment 805 before excavation.**

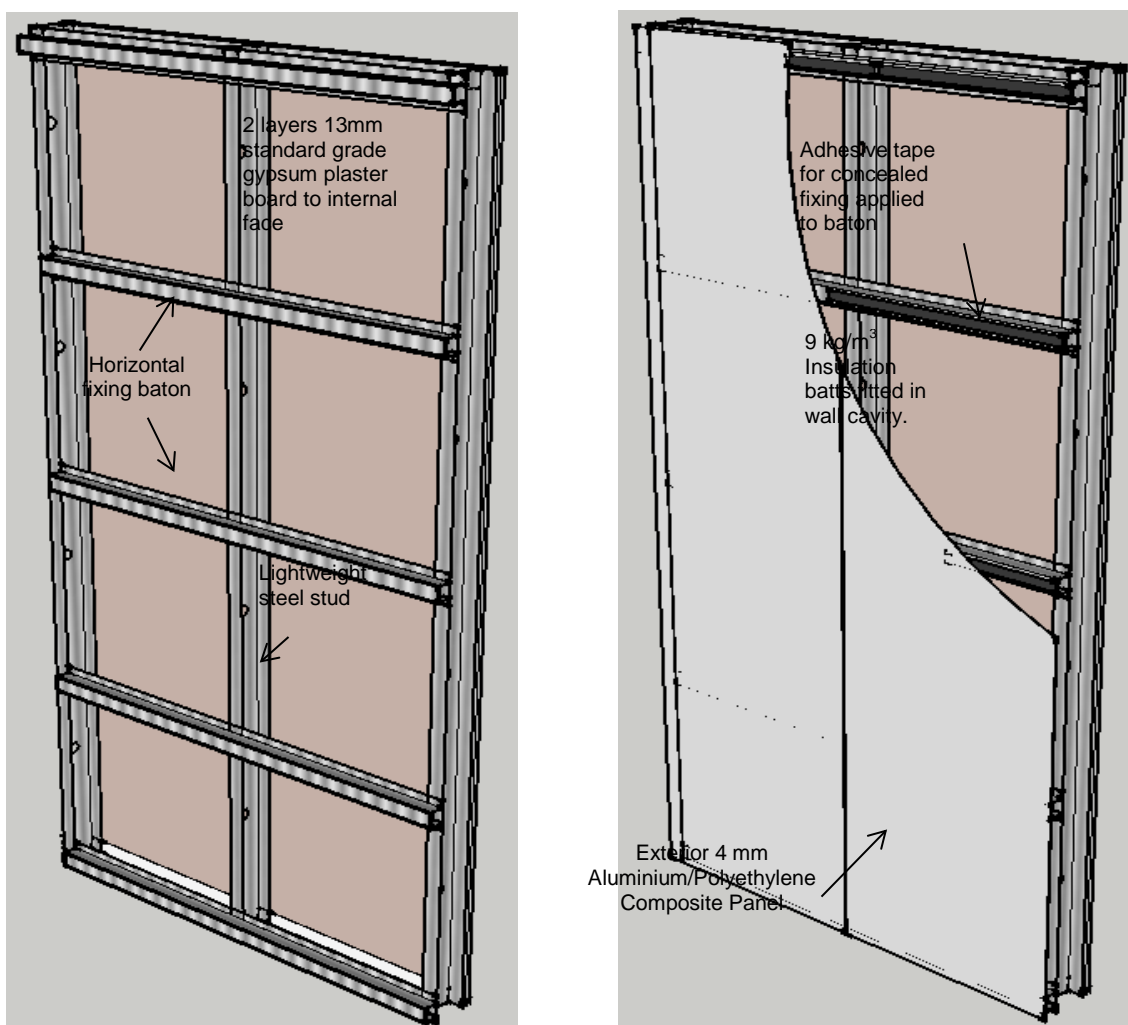
**Figure 9 - Aluminium/Polyethylene Composite Panel Façade - External Wall Cladding**

To the best of the MFB's knowledge, the labelling indicates an aluminium/polyethylene composite panel of 4mm thickness, in a colour known as Champagne Silver (*HY 103*). It is unclear what the value 11060167 represents, however, the number does loosely appear to correspond with the date and time shown at the end of the label and may indicate the number of manufacturing runs of this colour and type for the month. It is assumed this panel is the standard grade Alucobest panel, as there is nothing to indicate otherwise. The product is believed to incorporate a Polyethylene core material.

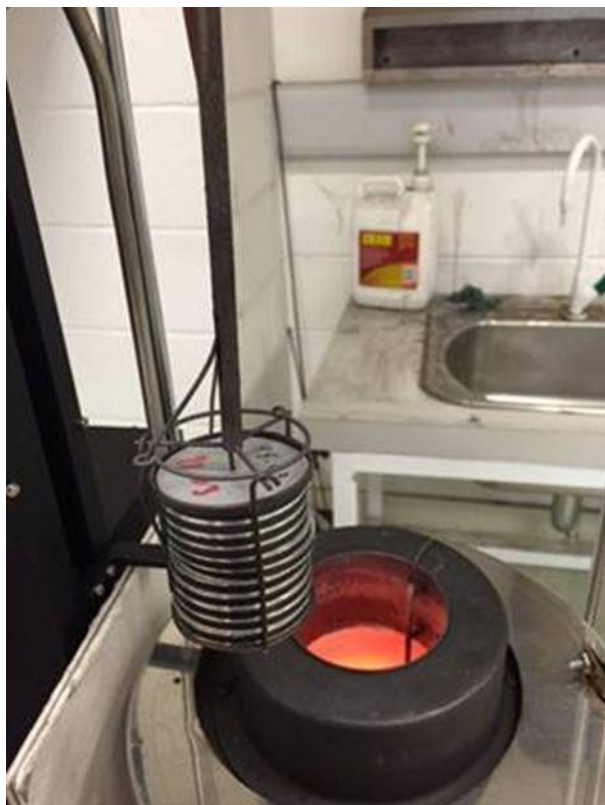
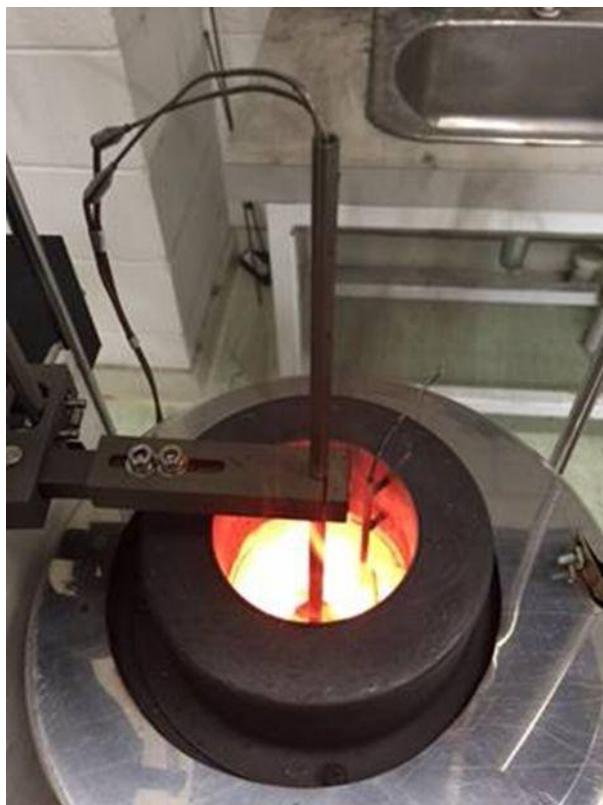
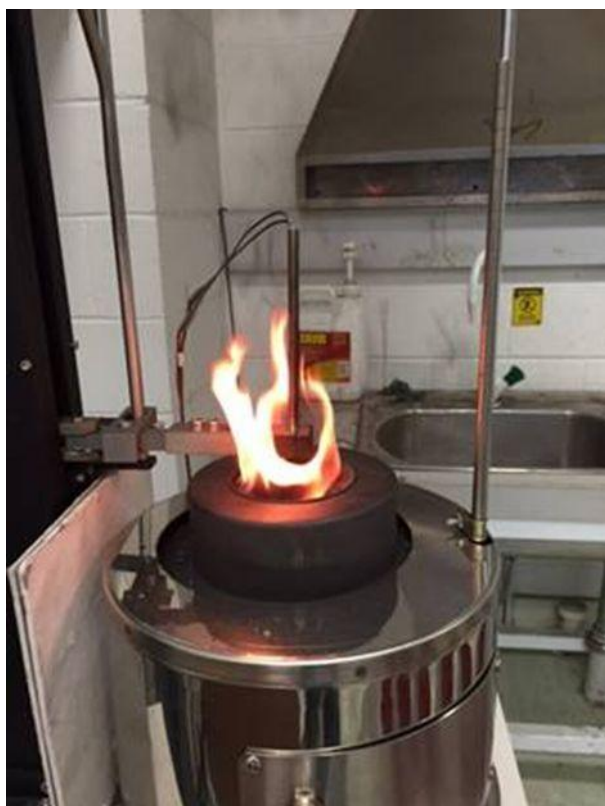
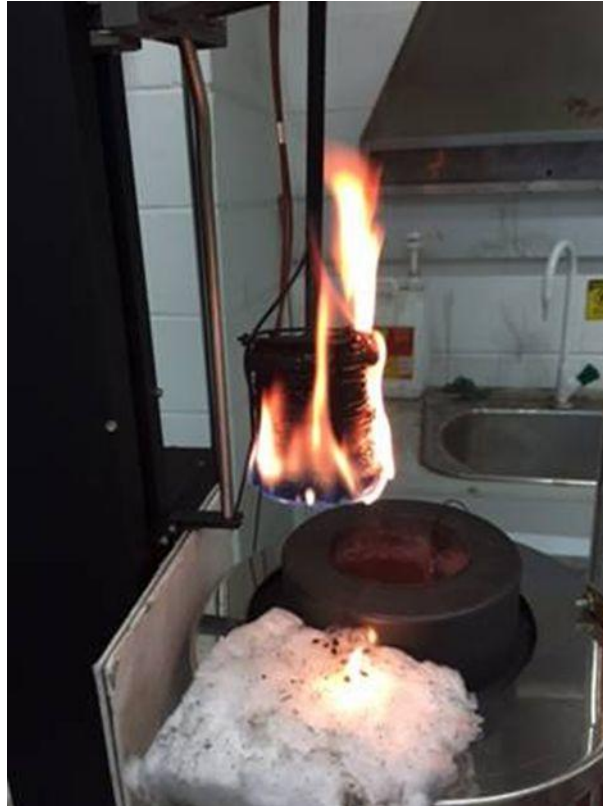
Specimen photos before, during and after the test.

***Observations:*** Sustained flaming was observed on the specimen at 55 seconds into the test. The test was terminated at 93 seconds due to excessive flaming and smoking.

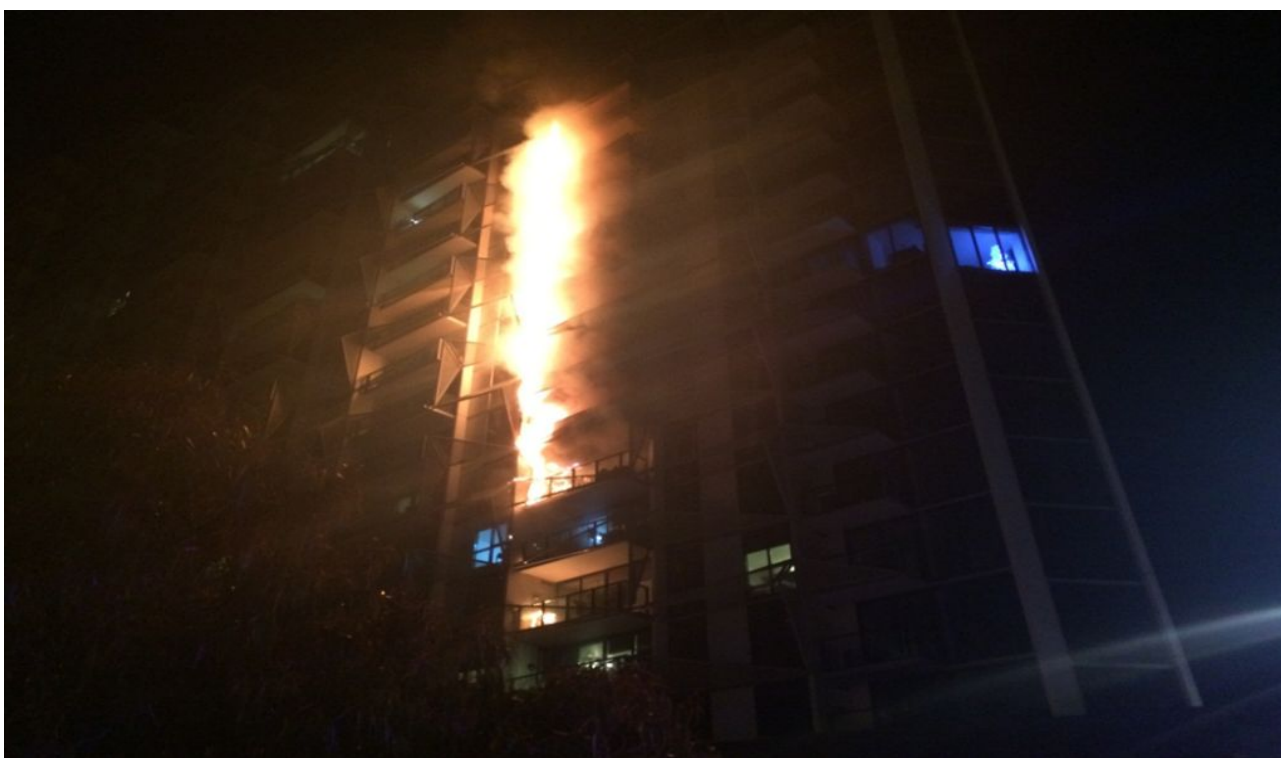
**Figure 10 - Time 02:29. Photo depicts the rapid vertical fire spread, only 4 minutes after level 8 sprinkler activation**

The MFB Fire Investigation team have determined that the fire originated on the balcony of the 8<sup>th</sup> floor. The FIP history log shows activation of the Level 8 sprinkler flow switch at 02.25 hours, one minute later than an exchange call received by the MFB. Fire crew arrived on scene at 02.29 hours, some five minutes later and reported vertical fire spread to approximately the 14<sup>th</sup> floor. At 02.35 hours, MFB crew reported that the vertical fire spread had reached the roof.

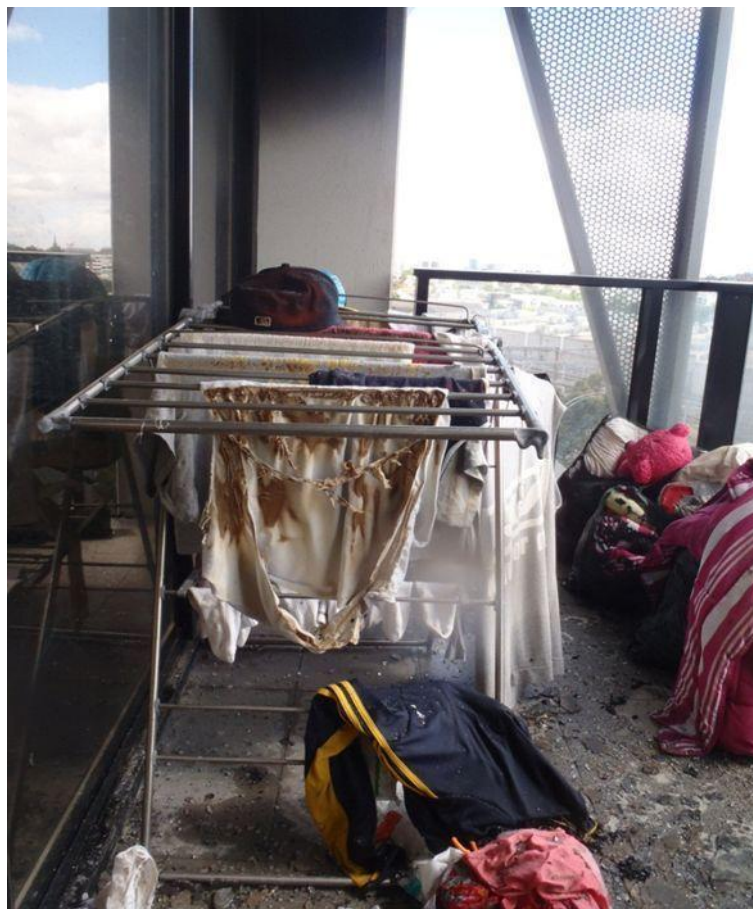
In this instance, typical combustibles identified to be present on balconies throughout the building consisted of clothing, bedding, bicycles, electrical appliances and other miscellaneous combustible materials, notwithstanding the air conditioner compressor units and other combustible furniture items. See Figure 11 below for example.

Figure 11 - Combustibles stored on one of the balconies.

High occupancy rates in apartments can lead to reliance on balconies for additional storage space, increasing the fire load.

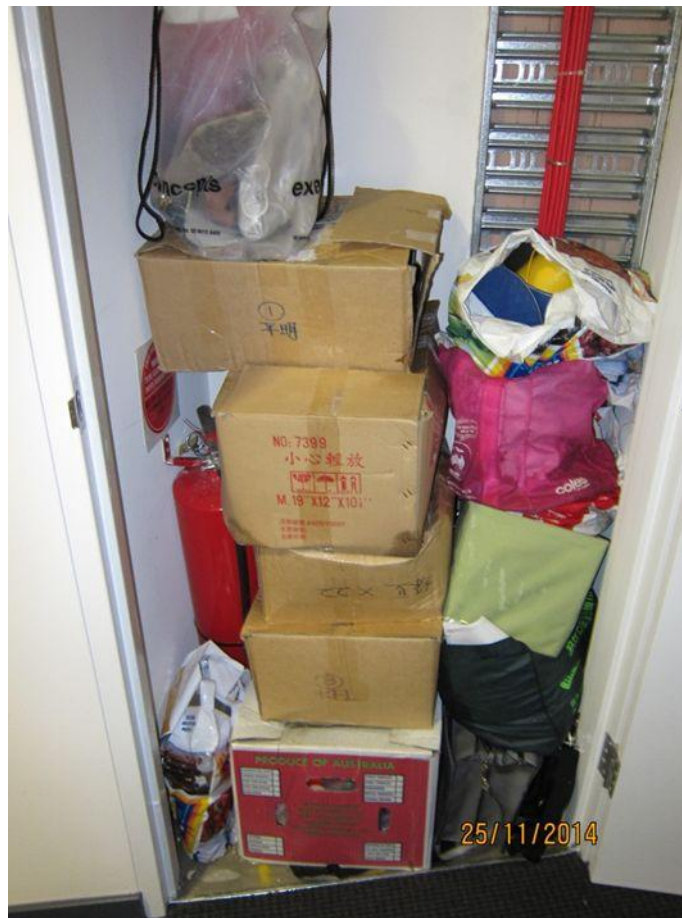
In this instance, a number of the purposely designed extinguisher enclosure housing Extinguishers 1 and 2 shown in [Figure 12 \(refer previous page\)](#), were being used by occupants as storage areas thus blocking access to the extinguishers.

**Figure 13 - Fire extinguisher cupboard on Level 6.**

The storage of goods and materials in enclosures used to accommodate fire safety equipment, delays access for occupants or fire-fighters who require the equipment in an emergency. These storage items are generally of a combustible nature and present an additional hazard.

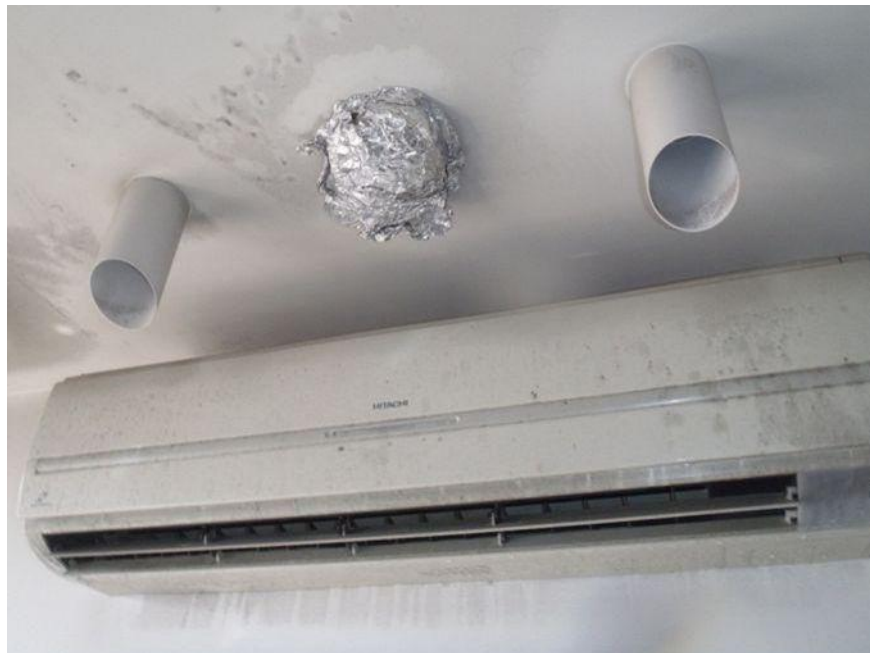
It was observed that within a number of apartments the battery had been removed from the smoke alarm. In addition some smoke alarms had been covered (Refer to Figure 14 below).

Figure 14 - An example of an obstructed Smoke Alarm – Apartment 805

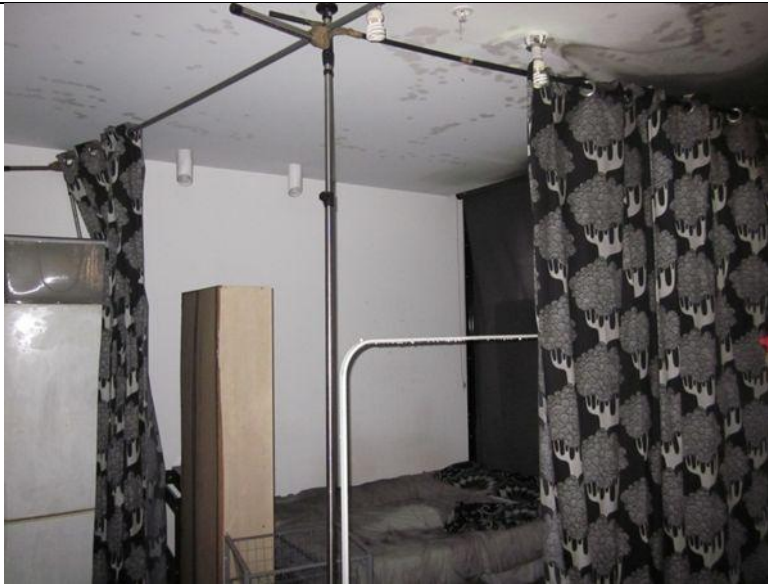
Living room cordoned off to create additional bedroom

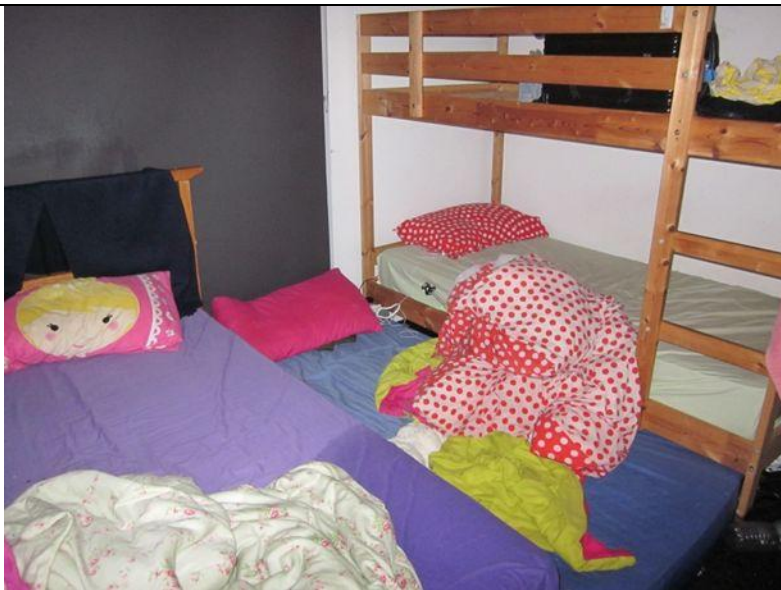
Multiple Beds in two bedroom apartment.

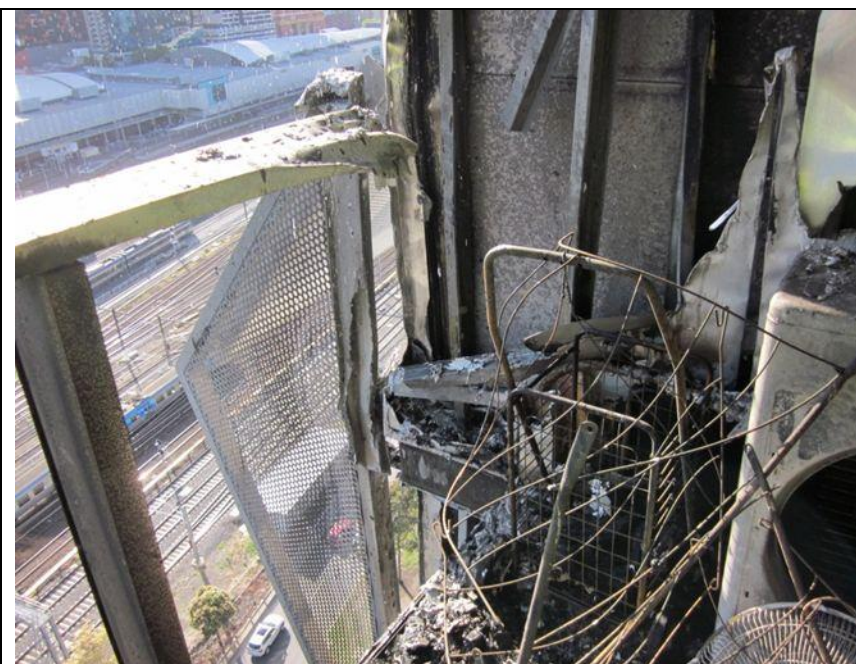
Wall between bedroom and balcony. Construction lightweight wall with steel studs, aluminium type external cladding plasterboard to internal. Material stored on balcony.

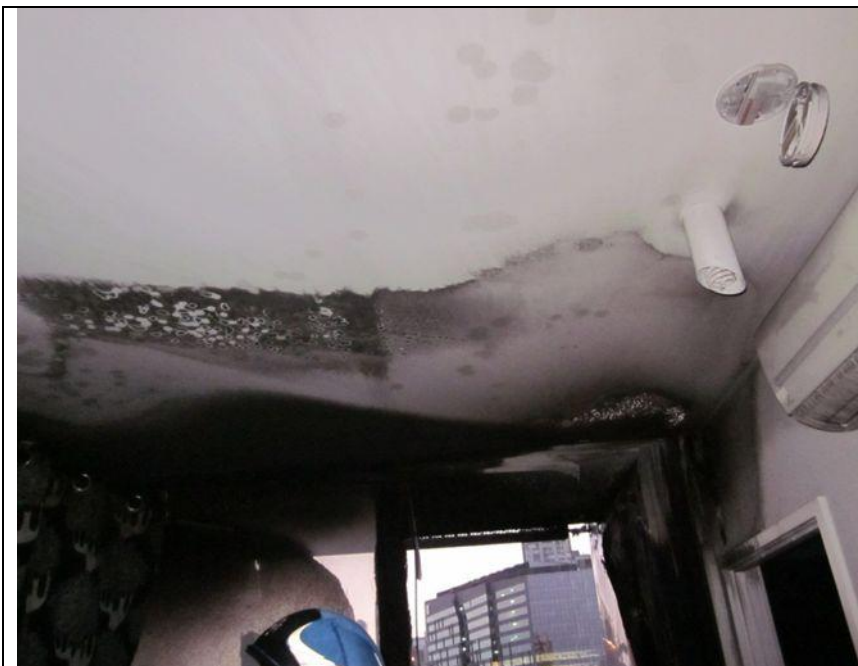
View of damaged wall and smoke detectors made inoperable. Others were covered over.

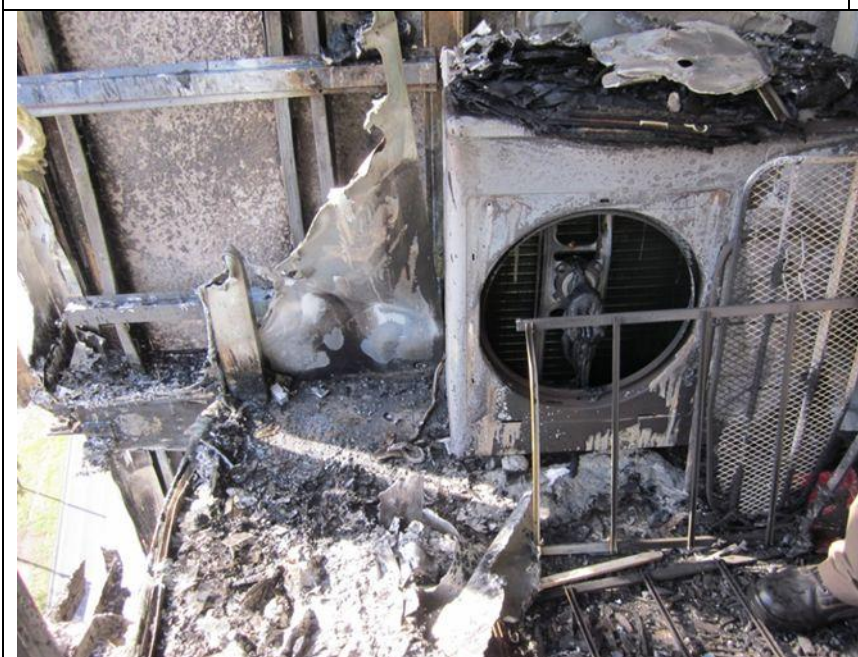
Photo of base of wall and penetrations plus overhang past balcony edge

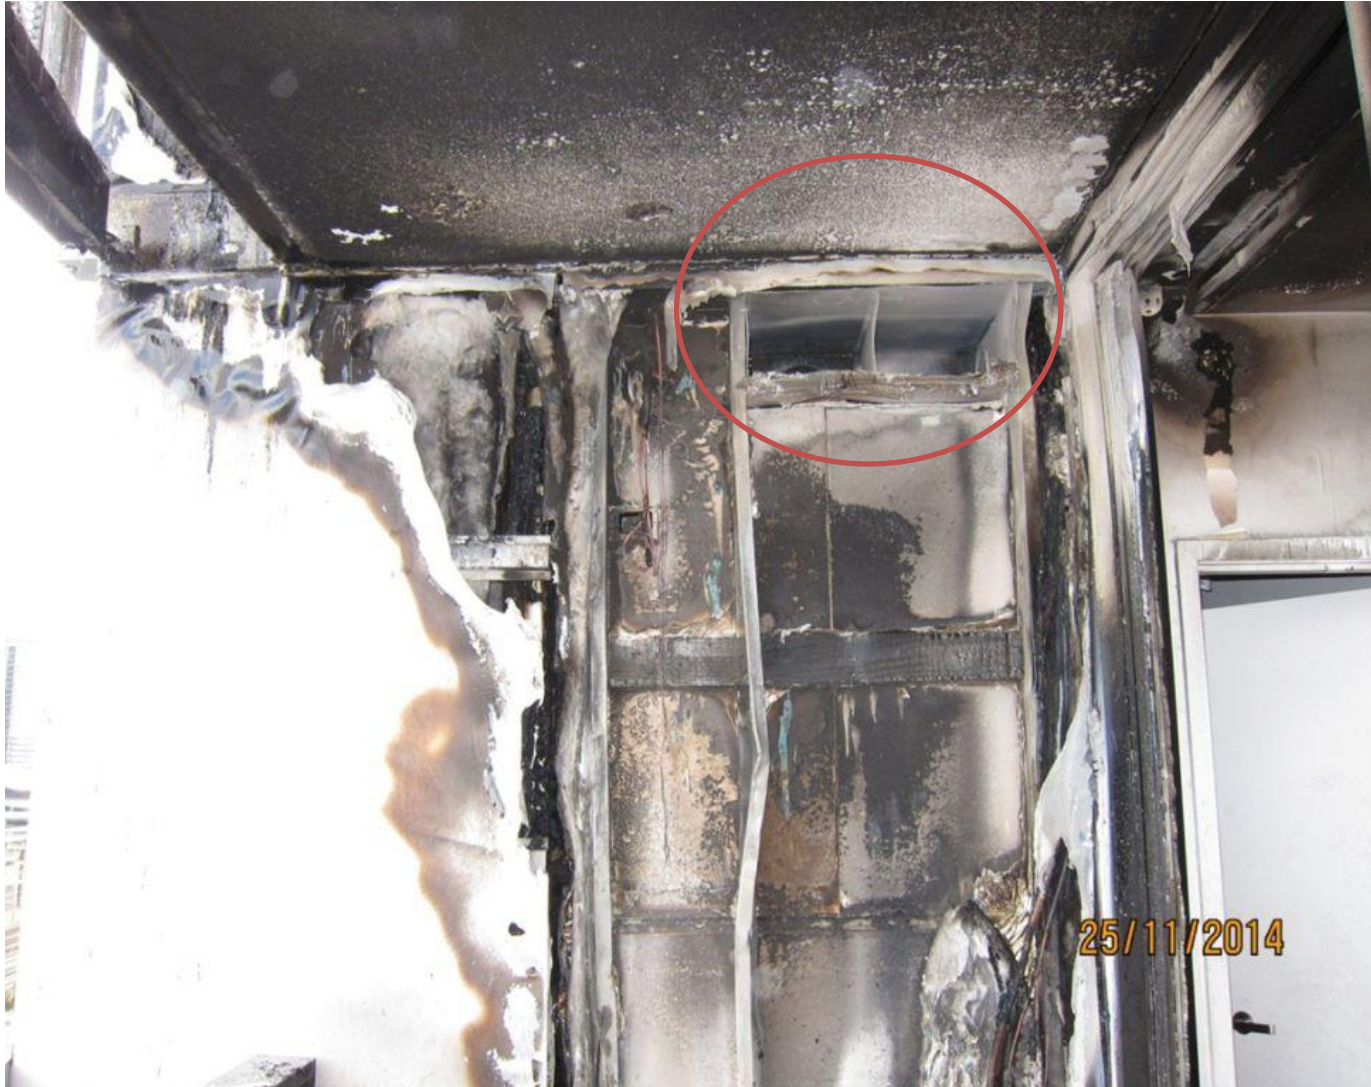
Image depicts apartment exhaust duct, the image also shows how close the door of Bedroom 2 is to the exhaust. The EWIS speaker is located roughly 400mm inside this door.

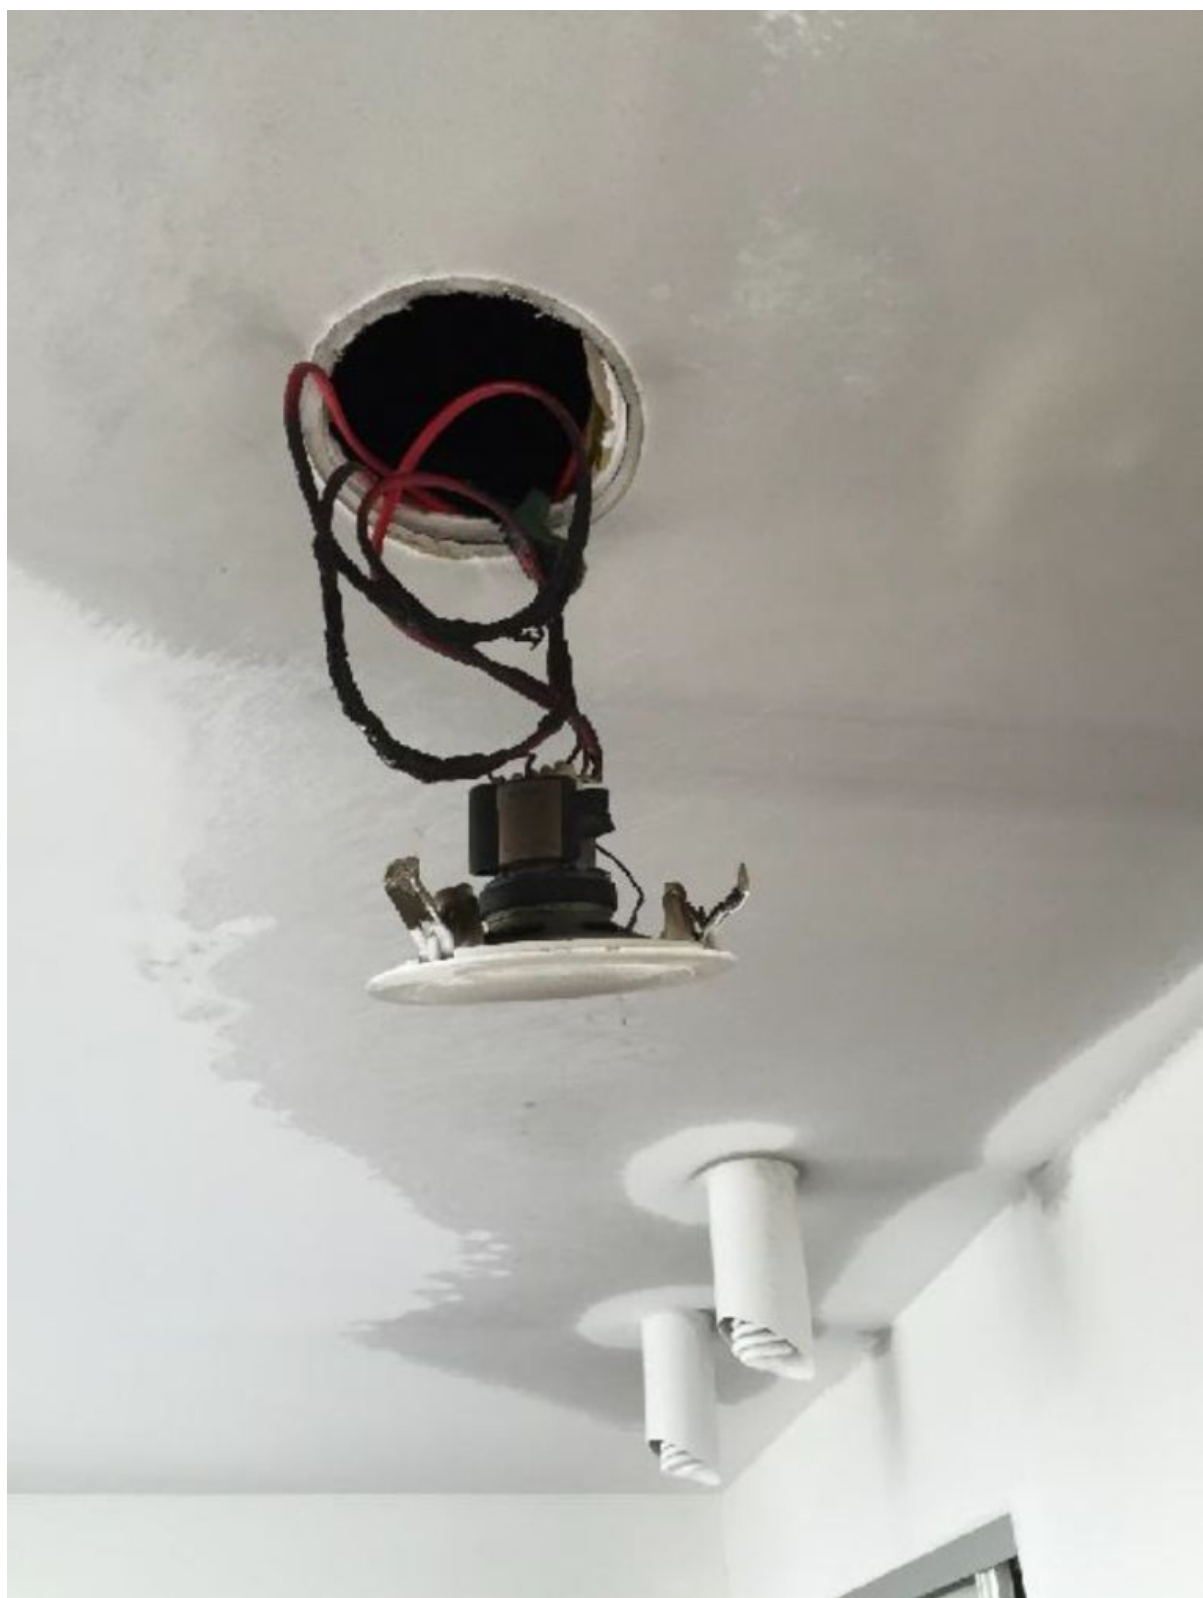
Image depicts the damaged caused to the EWIS speaker cables in Bedroom 2 of the 05 Series Apartments.
