# Post Incident Analysis Report

**MFB Burnley Complex  
450 Burnley Street  
Richmond VIC 3121**

Lacrosse Docklands  
673-675 La Trobe Street, Docklands  
25 November 2014

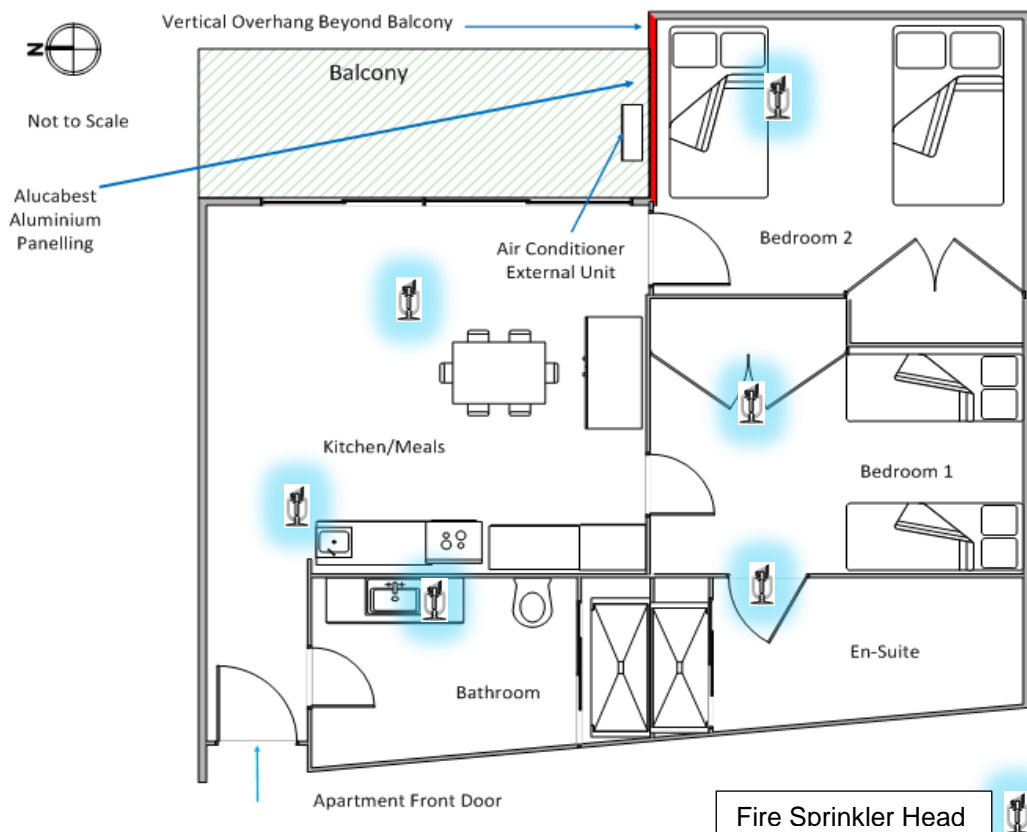
At approximately 01:30 hours on the morning of Tuesday 25 November 2014, an occupant from Apartment 805 of the building, claims he investigated the smell of smoke. After checking the kitchen and making sure the gas stove was turned off, he returned to bed. Sometime later, the same occupant was woken by two other house mates who had discovered the fire burning on the balcony.

From inside the apartment, he could see a fire on the right hand side (south) of the balcony. The occupants of the apartment unsuccessfully attempted to extinguish the fire using a container of water.

Figure 1 – General floor layout of apartment 805

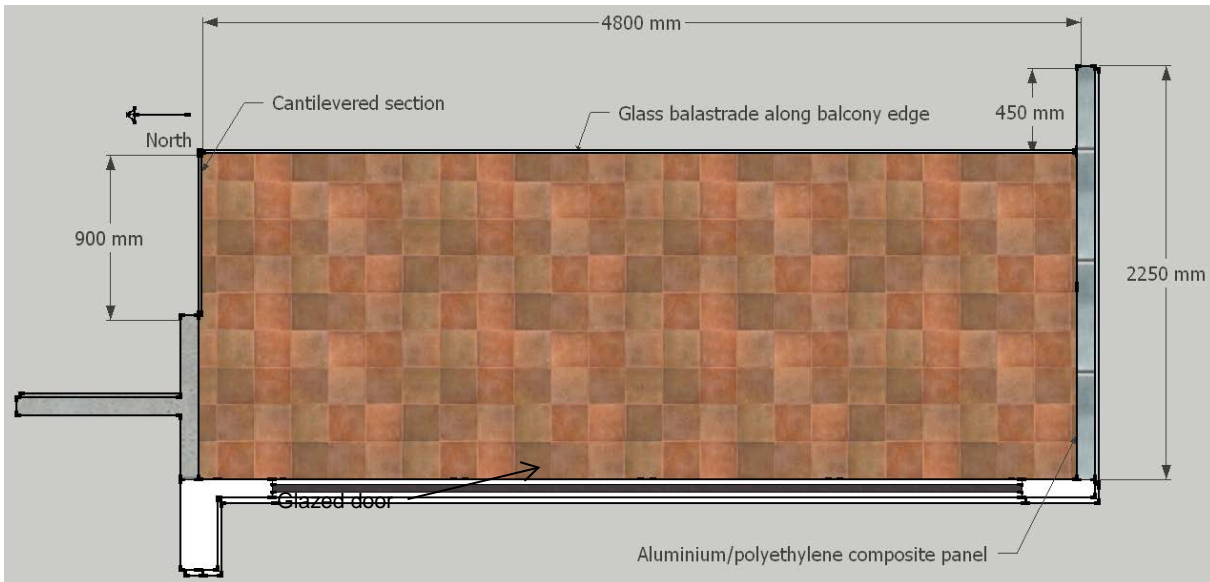
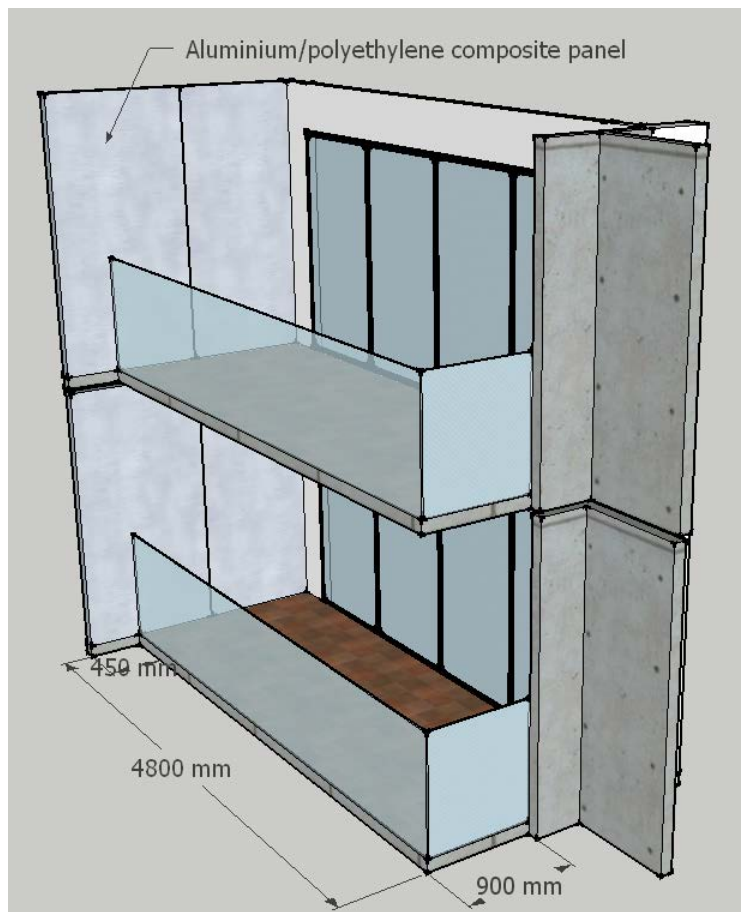
The apartments known as Apartments 605 to 2105 are located in vertical alignment from the 6<sup>th</sup> floor to the 21<sup>st</sup> floor on the east façade of the building. They include suspended concrete balconies of approximately 1.8 metres deep x 4.7 metres wide. A double-glazed sliding door assembly is fitted in the external wall of the building and provides access to the balcony.

The northern end of these balconies are bounded by 900mm concrete panels, which leaves the remaining 900mm balcony depth cantilevering out beyond the building face. A 1 metre high glazed balustrade is fitted to the remaining northern edge of the balconies and returns along the length of the eastern edge and butts into the southern wall.

In contrast to the northern end of these balconies, the walls at the southern end of the balconies extend out approximately 2.25 metres and some 450mm from the external face of the balconies.

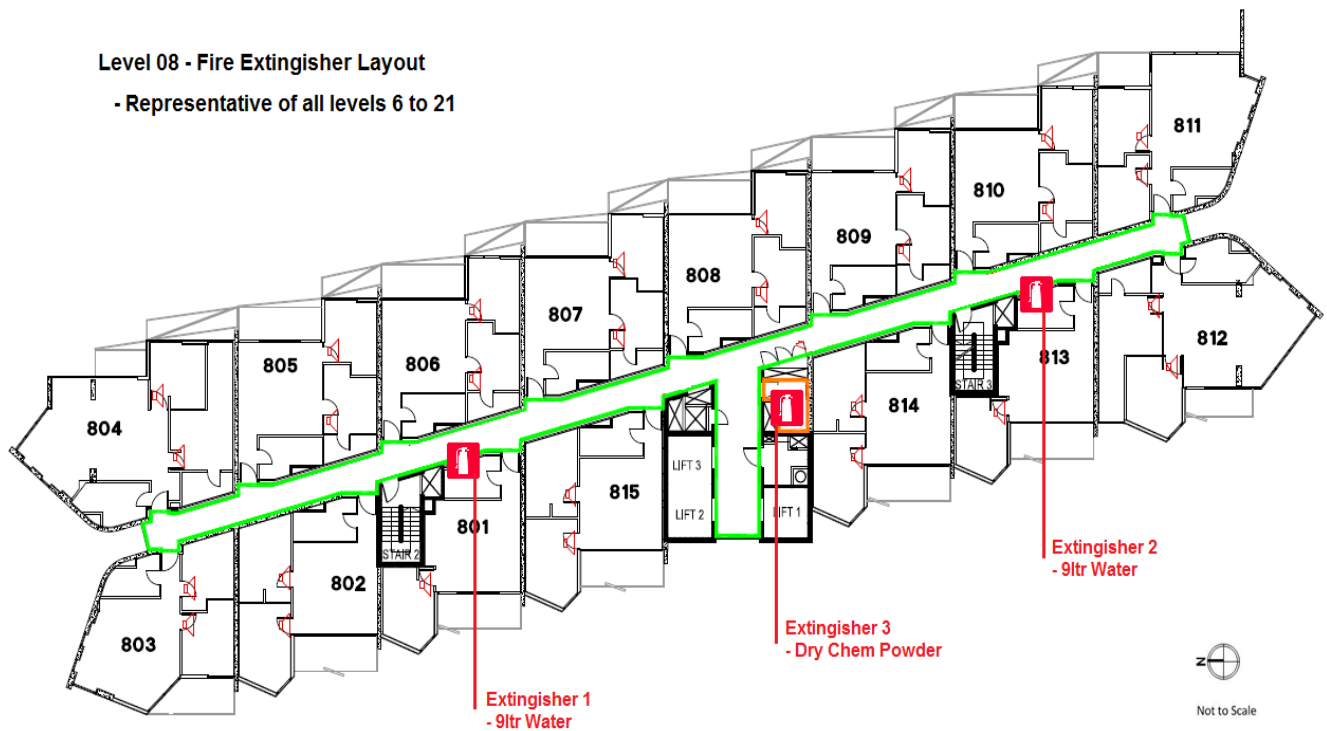
Figure 12 - Fire extinguisher layout

In this instance, a number of the purposely designed extinguisher enclosure housing Extinguishers 1 and 2 shown in [Figure 12 \(refer previous page\)](#), were being used by occupants as storage areas thus blocking access to the extinguishers.

It was noted during investigations that extinguisher three (as shown in [Figure 12](#)) on all residential levels was locked within a service room where they were inaccessible to occupants and fire-fighters.

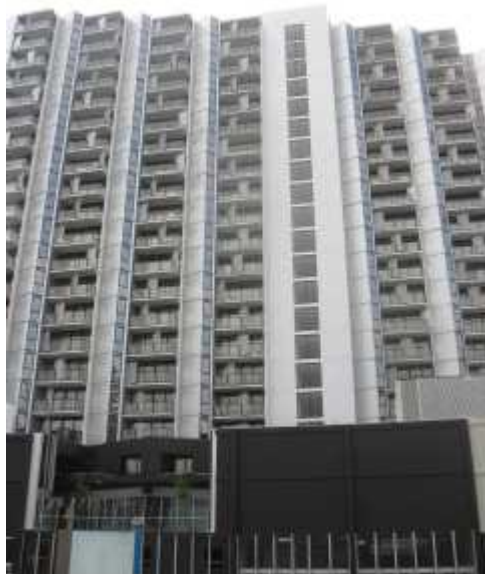
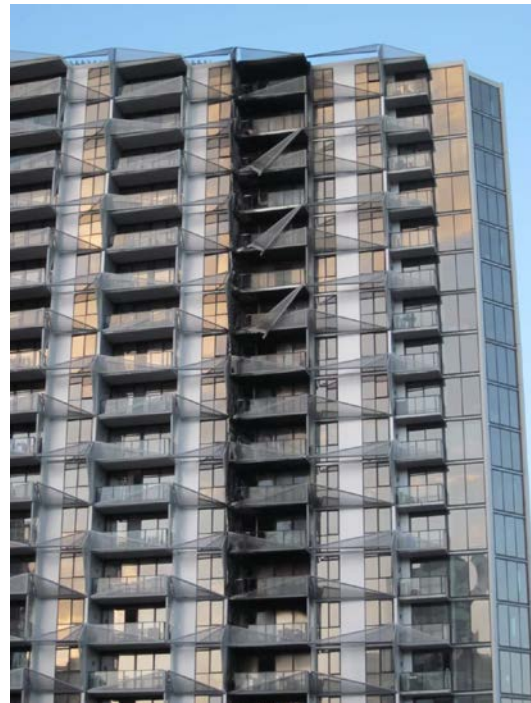
Photo Prior To Fire

Photo Post Fire

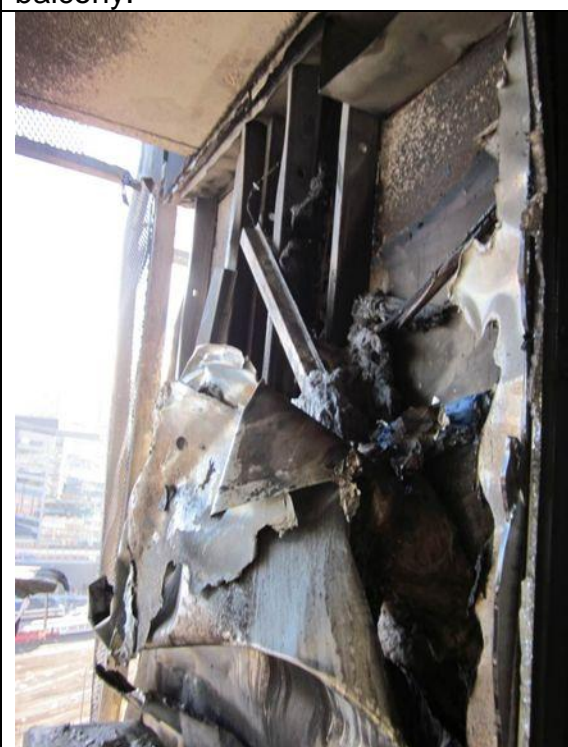
External wall at upper height

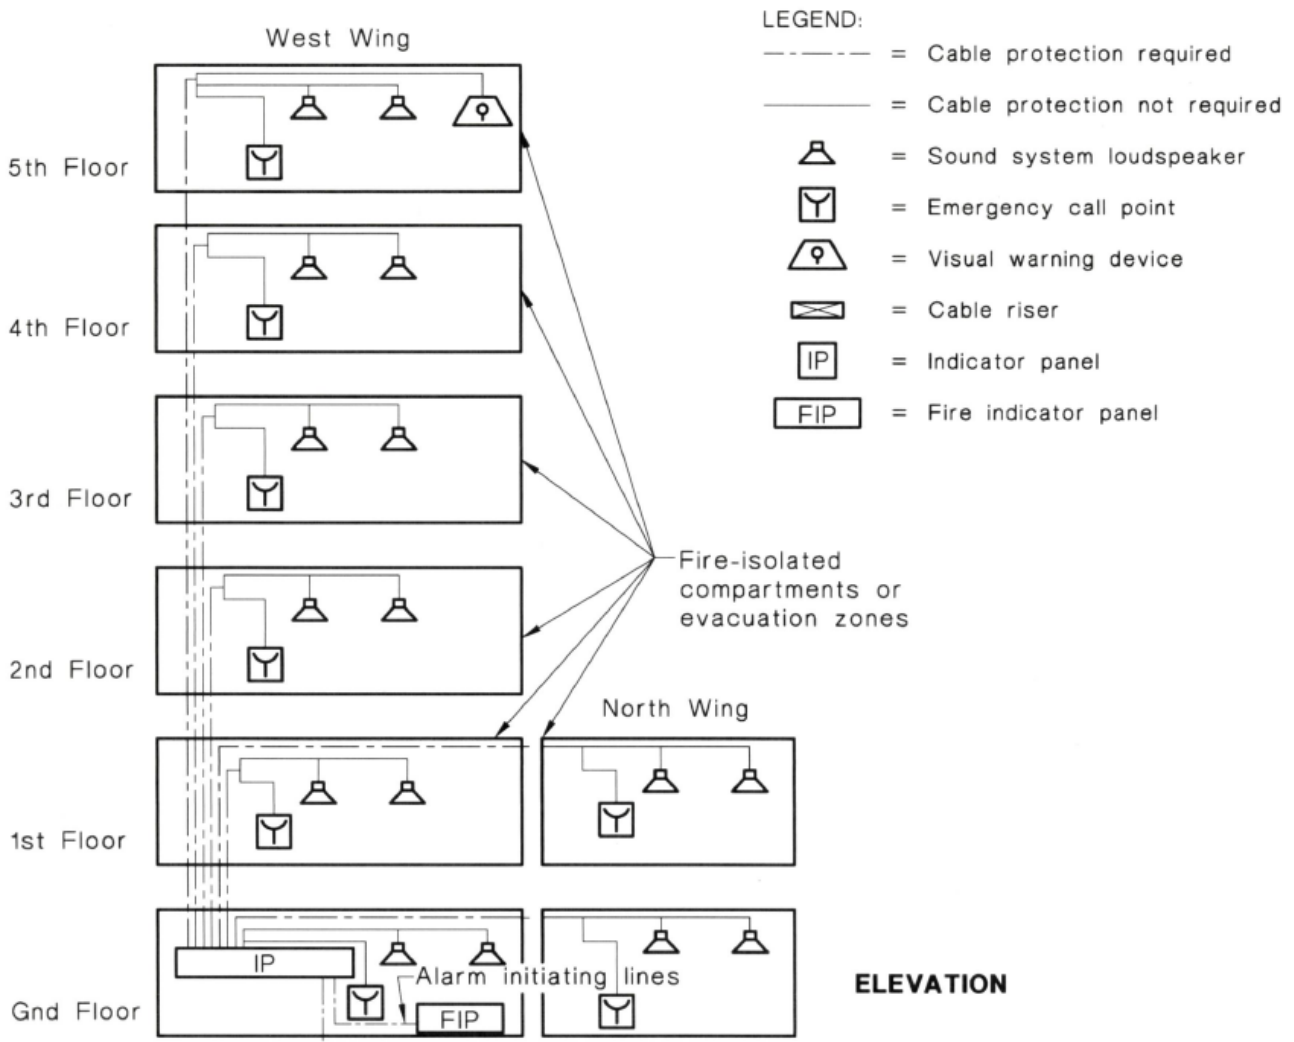
The EWIS system is designed and installed as per Australian Standard AS1670.4. This Standard requires all wiring between the EWIS's main panel and the evacuation zone to be fire rated. The zone wiring itself is not required to be fire rated, instead non-fire rated thermal plastic sheath (TPS) wire is used. Refer to [Appendix 6 figure 17](#).

Figure 17 - Wiring diagram for EWIS

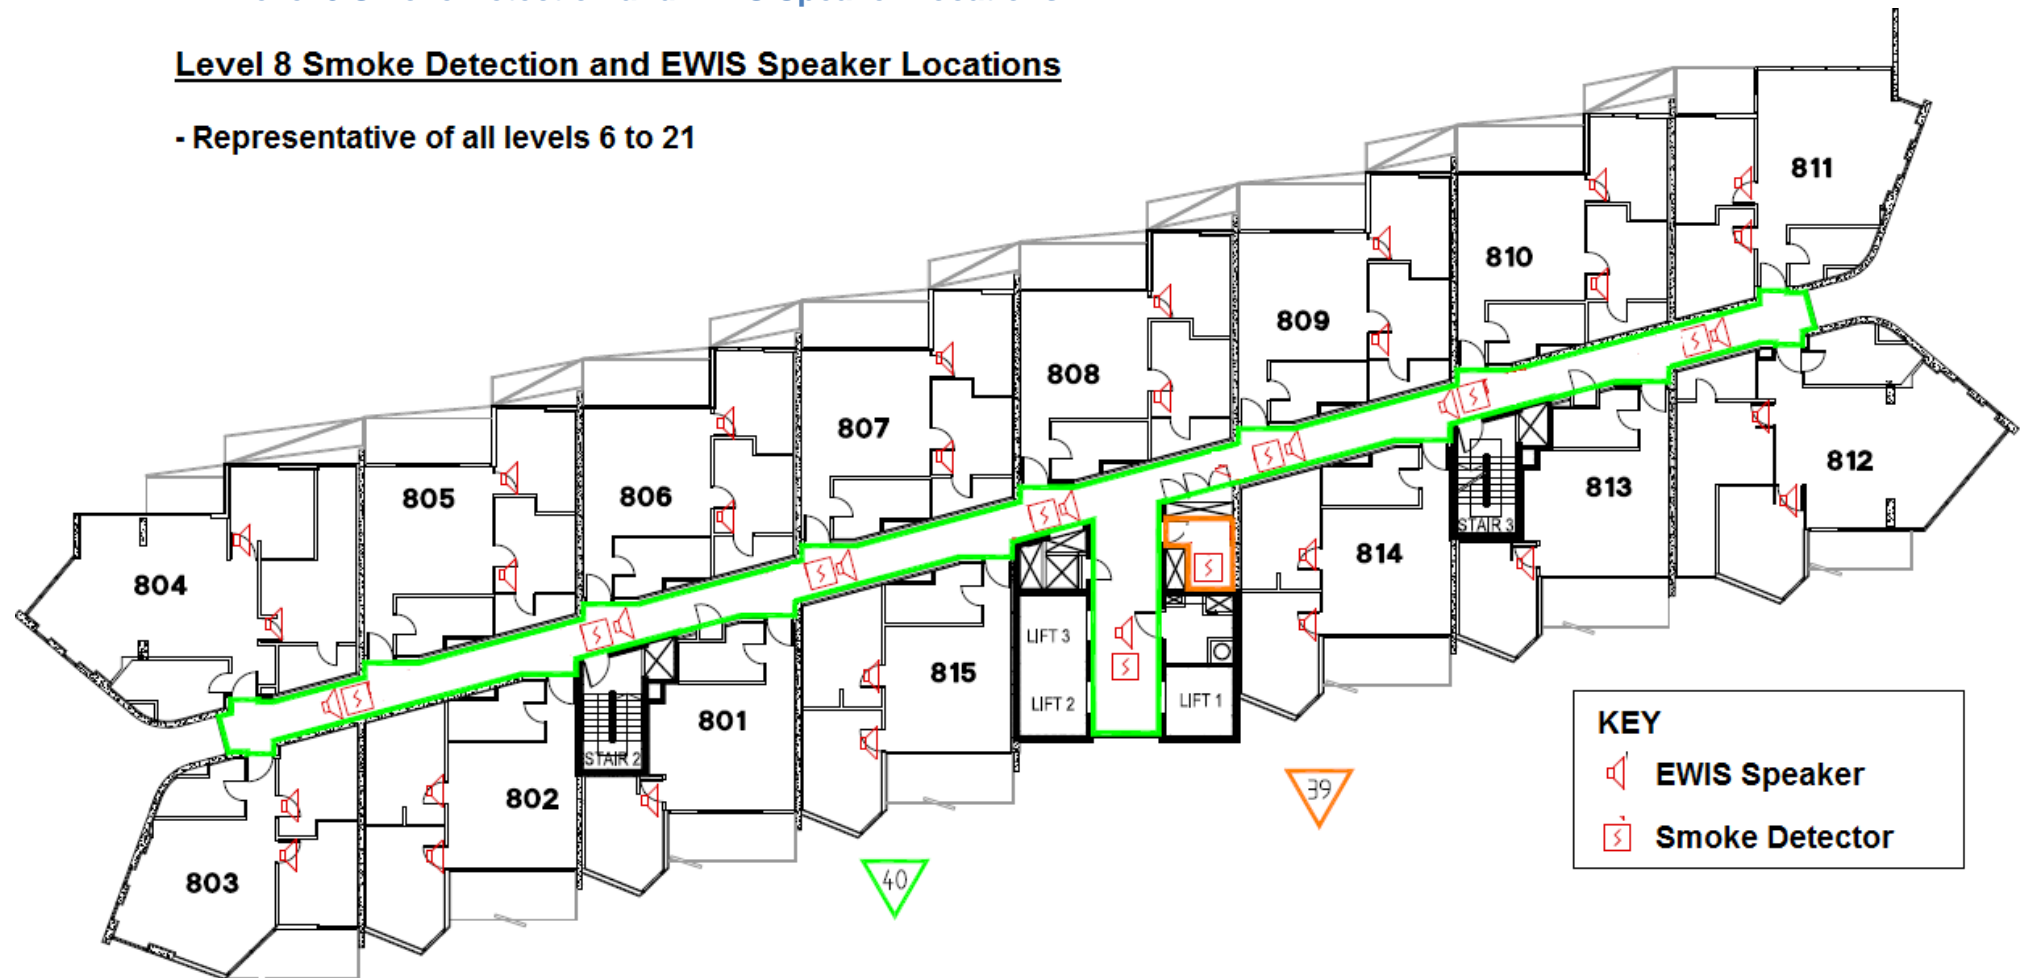
This building incorporates a smoke detection system throughout the common areas as required by the BCA. During investigations, it was observed that a typical apartment level consisted of eight photo-optical smoke detectors, installed throughout the corridor and an additional smoke detector located in the electrical riser cupboards at every level.

In total, 13 smoke detectors activated throughout levels 3, 6, 8, 9, 12 and 18. The FIP printout indicated that 25 minutes after the initial detector activated, the system started to log detector faults. Over 55 faults were logged, all of which are likely to be attributed to water damage from the operating sprinkler system.

Figure 18 - Level 8 Smoke Detection and EWIS Speaker Locations

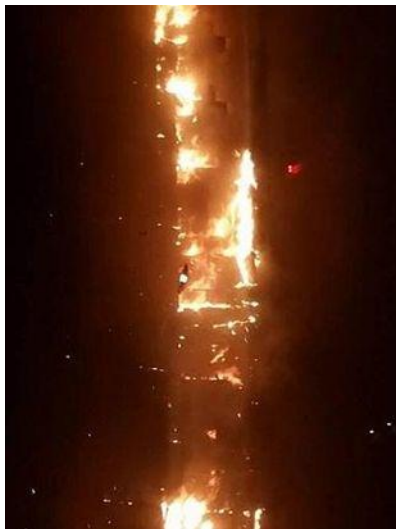
### Torch Tower Dubai 21 February 2015

- 79 Storey residential;
- Reported as same façade material as the other Dubai fires shown - Aluminium/polyethylene composite panel facade;
- Fire Origin 52nd floor
- Rapid vertical spread up the façade of the building and significant flaming falling debris

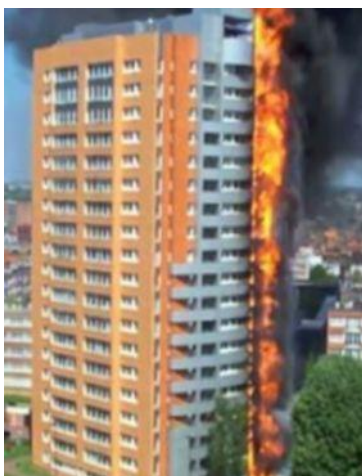
### Mermoz Tower, Roubaix, France, 2012

- 18 storey residential building;
- Aluminium/polyethylene composite panel facade;
- Fire origin – 2nd storey balcony;
- Fire description - “rapid vertical flame spread to the top of the building within a few minutes”.

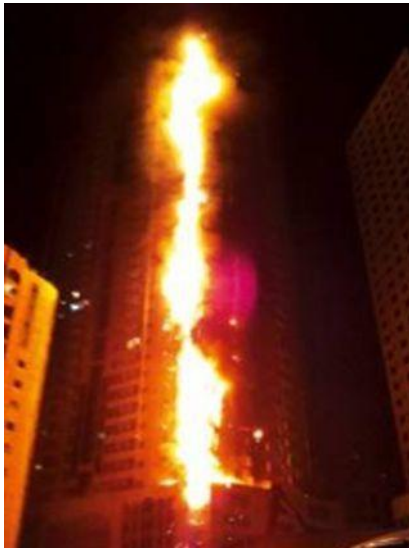
### Al Tayer Tower, Sharjah, 2012

- 40 storey residential building containing 6 carpark levels;
- Aluminium/polyethylene composite panel façade;
- Fire origin – 1st storey balcony;
- Fire cause – “discarded cigarette landing on the balcony which contained cardboard boxes and plastics”;
- Fire description – “vertical fire spread on the metal composite cladding to the top of the building”;

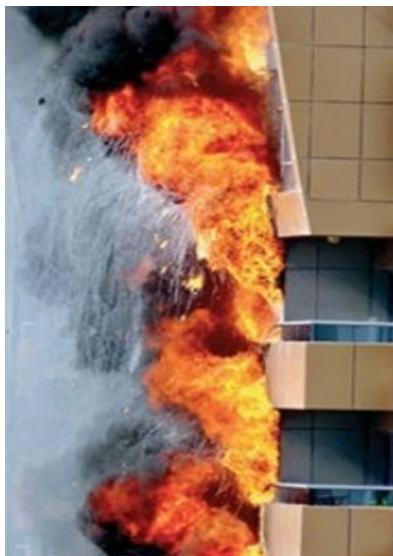
### Saif Belhasa Building, Tecom, Dubai 2012

- 13 storey residential building;
- Aluminium/polyethylene composite panel façade;
- Fire origin – 4th floor;
- Fire description – “fire rapidly spread to reach the top of the building”

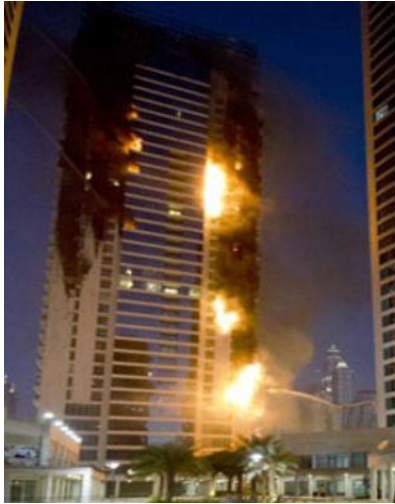
### Tamweel Tower, Dubai, 2012

- 34 storey residential building (contains mixed use)
- Aluminium/polyethylene composite panel façade;
- Fire origin – roof level
- Fire description - “spread down the exterior of the building.”

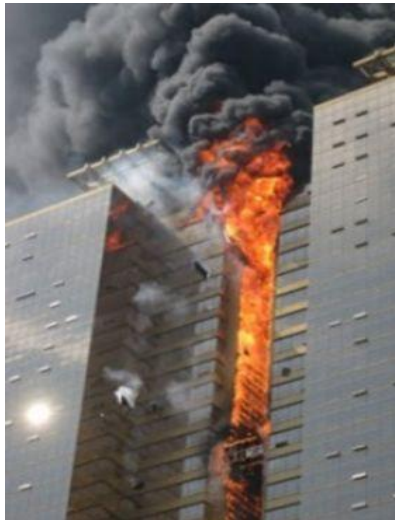
### Wooshin Golden Suites, Busan South Korea

- 42 storey residential building (contains mixed use);
- Aluminium/polyethylene composite panel façade;
- Fire description - “spread vertically upward on the façade reaching the top of the building”
- Fire origin - fourth floor;

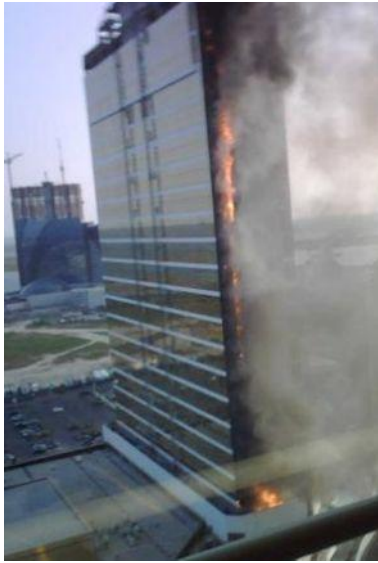
## Water Club Tower, Atlantic City, USA

- *41 storey building under construction;*
- *Aluminium/polyethylene composite panel façade;*
- *Fire origin - internal fire on the 3rd floor;*
- *Fire description – “fire spread vertically and rapidly reached the top of the building”.*
